RESIDENTIAL INSPECTION

Roozbeh Farahanipour

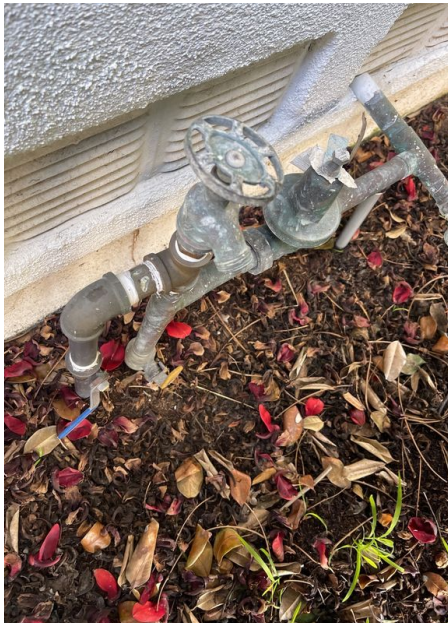
Hose Bib(s): No Anti-Siphon Valve(s)

One or more hose bibs may not have anti-siphon valves. Recommend adding anti-siphon valves to all hose bibs as needed as an upgrade.

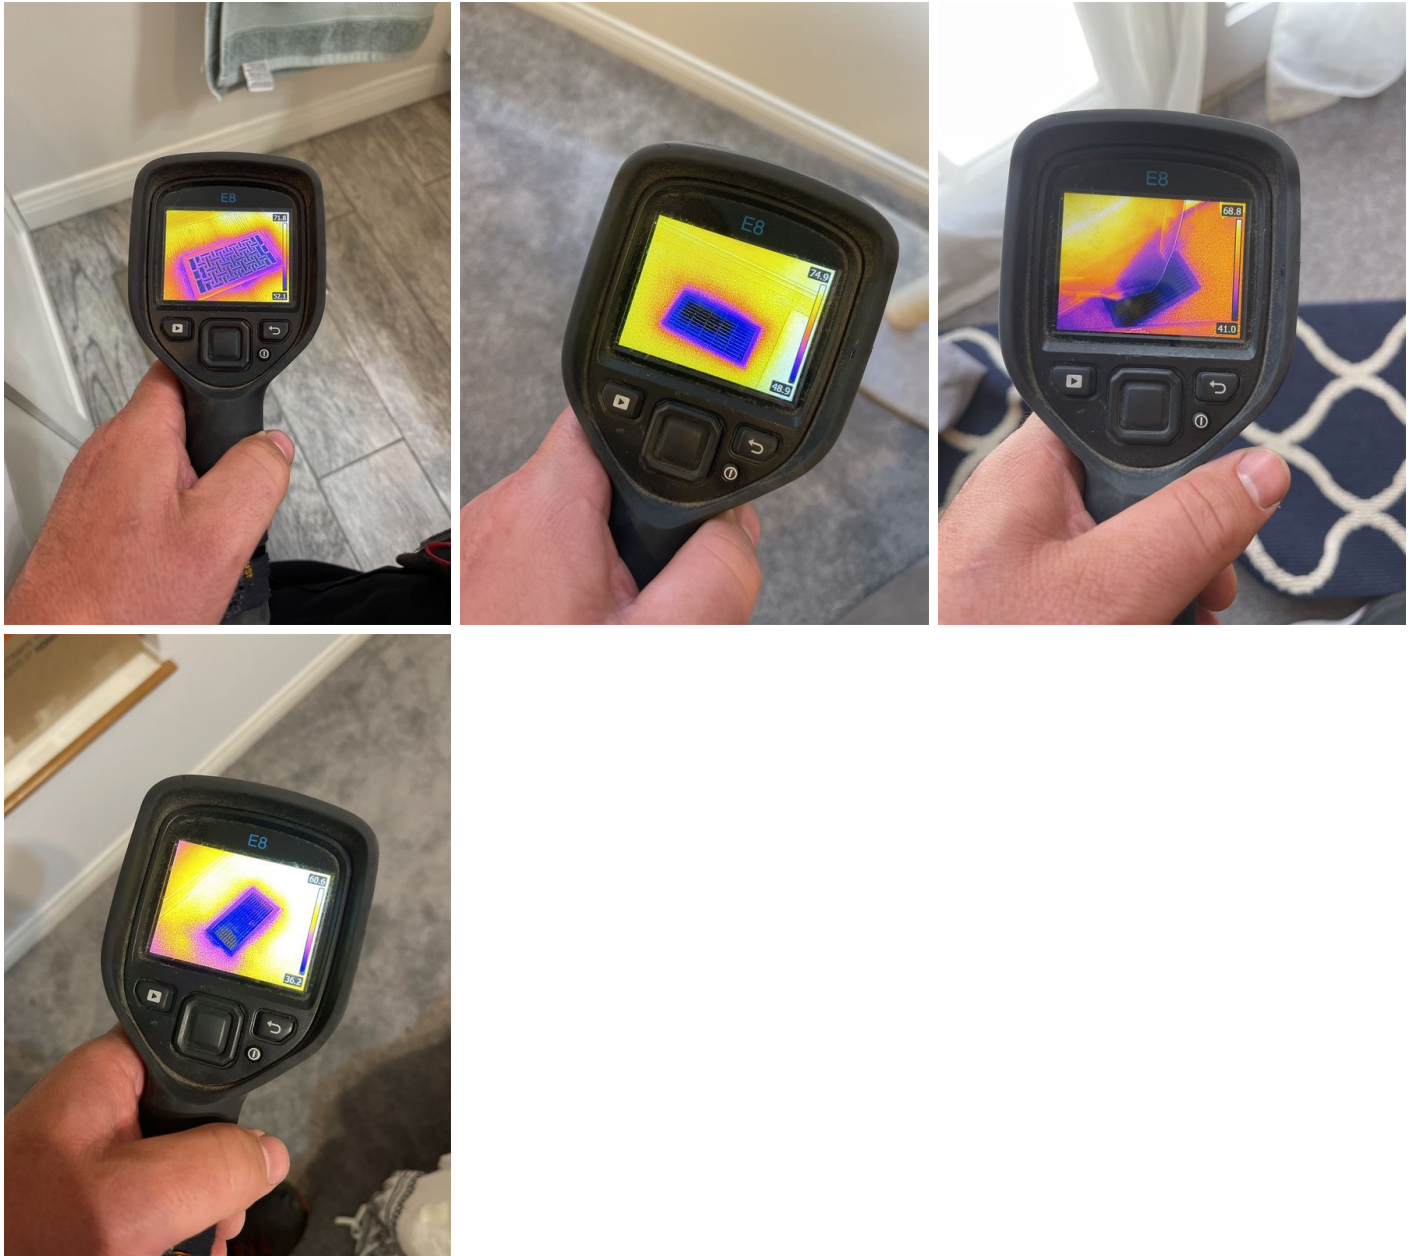
Cooling Equipment: Infrared Photo Of Air Conditioner ON
